Oberon Tarana Heritage Railway Inc.

Restoration of the OTHR Wickham 'Section Car' - PAGE 1

The Wickham Rail Car Report 4 June 2008

The Wickham Rail Car Report 2 April 2008

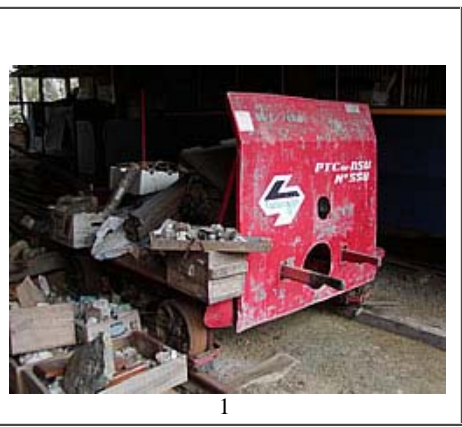
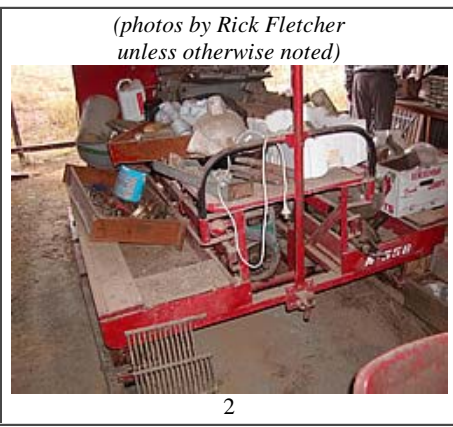
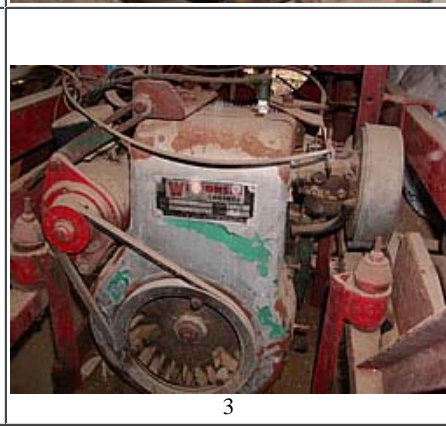
The section car as found.

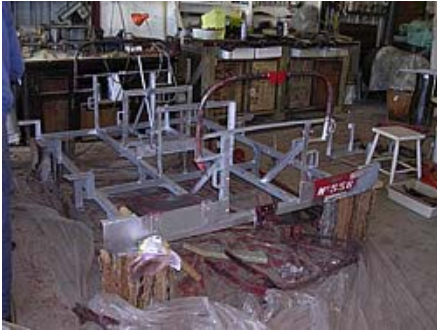
10

Chassis progress as at 2nd April 2008

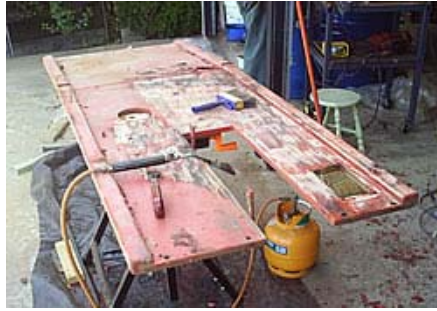
11

Seat cover undergoing restoration by Harry.

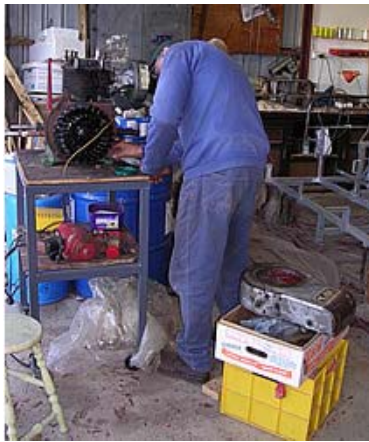
13

Arthur does some careful cleaning of the original engine paint.

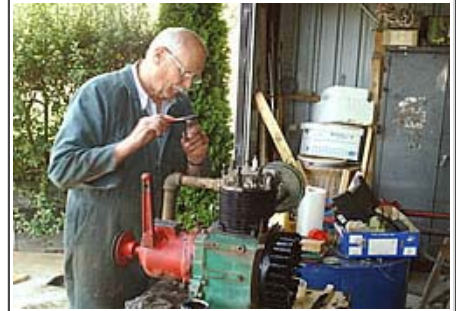
15

Ross is preparing the surface for re-coating.

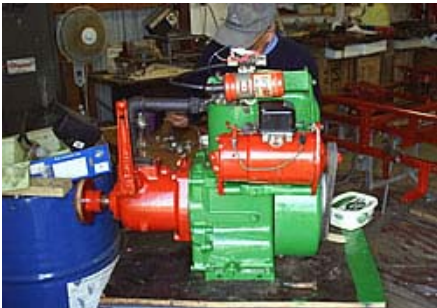
16

Finishing touches on the engine paint work .

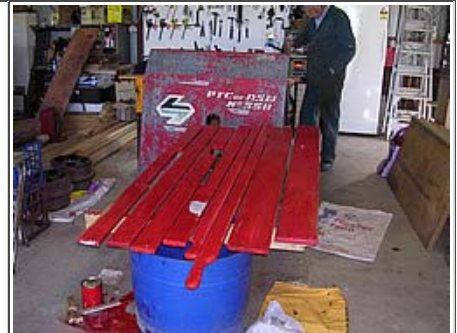
18

Timber parts have received a first finishing coat to match the existing paintwork

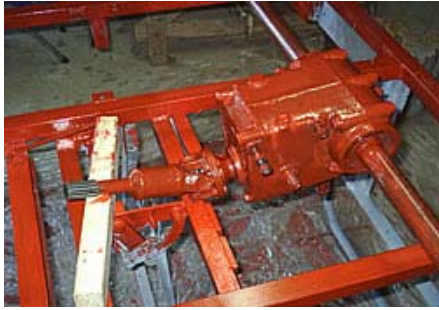
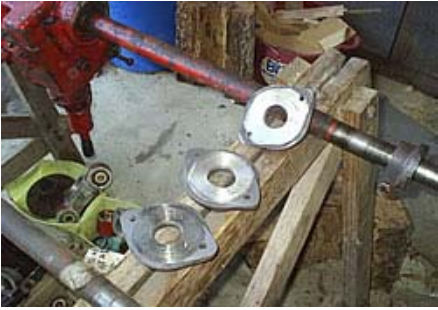
<p style="text-align: center;">23</p>		
<p>Gearbox and transmission system.</p>	<p>Thrust bearings after metal filling and re-machining.</p>		
<p>Also see: Page 1</p>	<p>Page 2</p>	<p>Also see: Page 3</p>	<p>Also see: Report</p>

- Suspension bolts were both bent and distorted as a result of the brake rod failure.
- Suspension rubber bushes were perished.
- Wheel bearing side thrust plates were (in 3 cases out of 4) badly worn down, which could result in speed wobble and possible derailment.

- stripped back all paintwork and applied rust and rot controls. We have begun the re-painting of the frame, woodwork and engine parts.
- welded and re-surfaced the side thrust plates.
- re-bushed the suspension.
- bushed the direction control lever.
- repaired the engine exhaust valve and the carburettor, and supplied a battery and coil and renovated the electrics and test run the engine.
- drained the water and old oil out of the final drive and washed it with kerosene ready to be re-filled with oil.
- cleaned up all the wheel bearings and housings ready for re-greasing.
- made and supplied new mounting bushes for the engine mounting and suspension system.
- replaced the fuel line and filters.

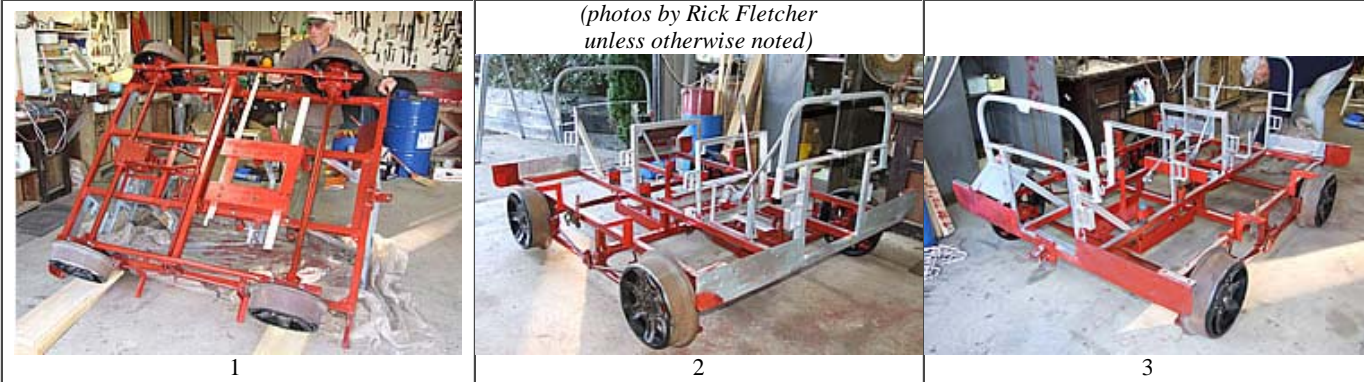
Early May 2008 and the chassis is ready to be set back on its wheels.

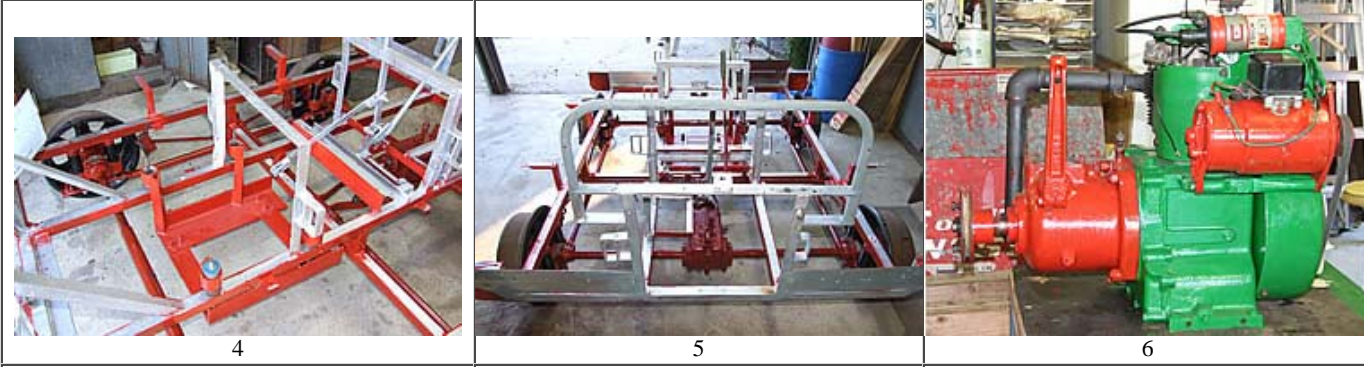
Engine reassembled.

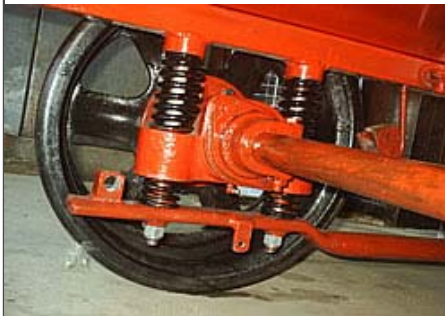
14

Suspension detail, awaiting final painting.
