History on the Move

Newsletter of Oberon Tarana Heritage Railway April 2025

HS36 Update

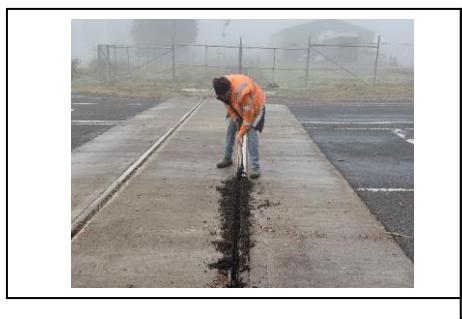
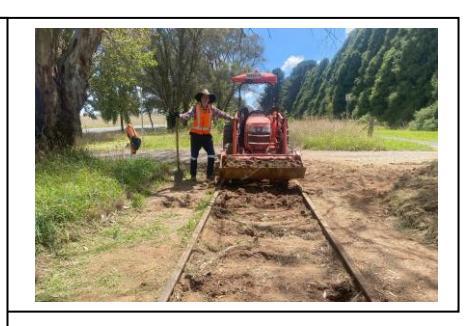
Left: Early in the morning President cleaning the gap. Photographer is also the lookout! Right: Trent Elliott, posing for a photo, while having a break from removing road base, leaves and other tree debris near to one of the crossings between Clover Lane and Rutters Ridge Road.

We are now giving extra attention on a regular basis to the level crossings by cleaning out the guard rails and removing road base build up that accumulates in the crossings during heavy rain. We have found out that once it has been cleaned out properly if it down about three weeks later it is a simple matter to run a crowbar or use a pick between the rail and guard rail and then blow it out.

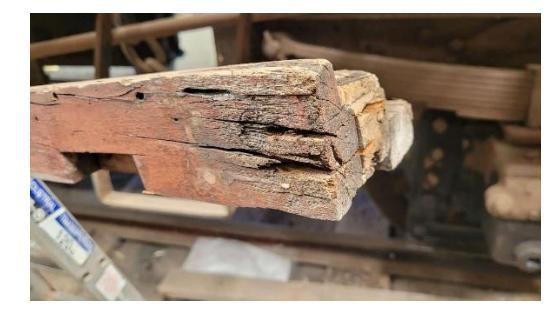
Rotted bottom guard door jam.

- Removed inner opening N/E guard door. Door jamb lower tenon had rotted away meaning the bottom of the door jamb was free to swing away from the frame. Horizontal connecting noggins under the ducket were removed to allow jam removal. Jam was cleaned up with all nail and screw holes dowelled. Rot was cut out of the lower jam, new timber spliced in. A new tallowood tenon was cut and then spliced into the door jam. New upper tenon retaining plate made up as old plate had split and no longer effective. Door jamb reinstalled and now very solid.

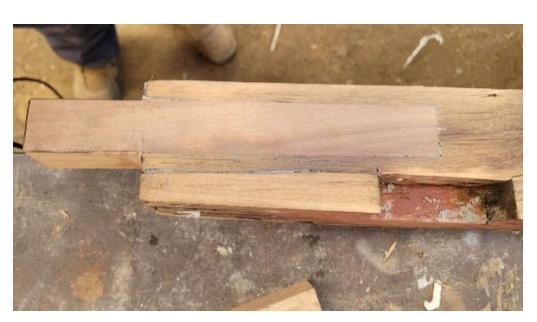
New tenon inserted into bottom of guard door jam and new timber rot repair.

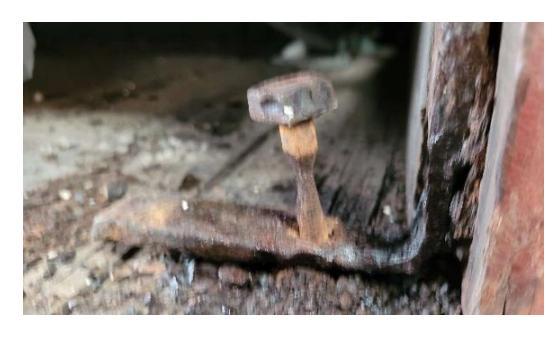
Wasted iron knee to be replaced.

- Old lighting cabling was removed from D36 compartment and new cabling installed.
- Bottom iron knees are rusted out and need replacing. One removed to date for duplication.

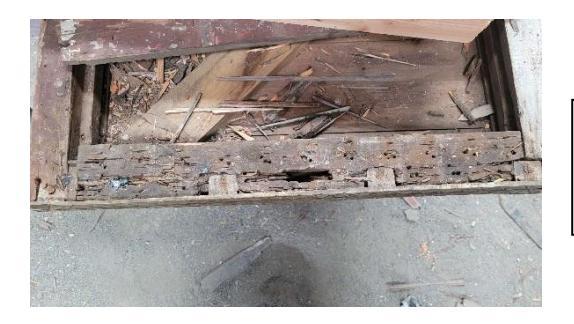
Bottom of outer swinging guard door showing rotten rail. Since renewed.

- Guard door stripped of rotten matchboard. Bottom door rail found to be rotted out badly. Bottom brass plate removed and new timber rail made and fitted. Quite complex. Removed guard door window. Opened top of door frame for removal of warped and split name board. New name board made from marine ply.

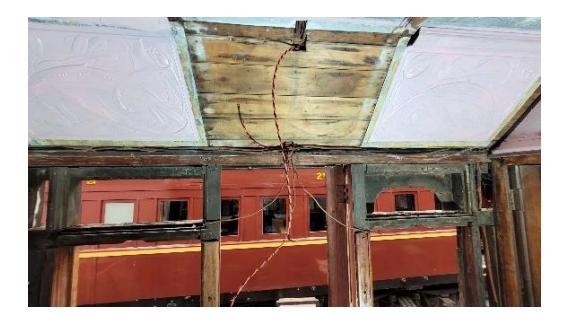
Pulling new lighting cables. Compartment D36.

- Pulled all new cables for D36 compartment, D36 lavatory and C36 lavatory, a very challenging task.
- Received new custom-made window bumpers from STG Industries in Ingleburn NSW. Supplied in 60 duro of good quality.

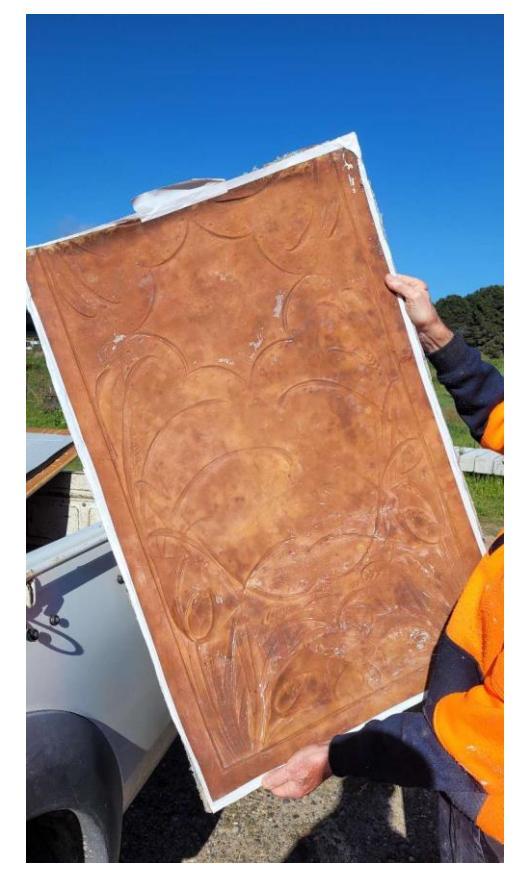
Latex mould produced to allow fibreglass repairs to zinc ceiling panels. Only half is required as the mould is reversed to create the second half. This is the same process they used when stamping sheets from zinc. They only had half sheet tools, stamping one half of the sheet first then reversing the sheet to stamp the other half.

- As per our previous report we were looking at creating a fiberglass mould to enable duplication of the zinc ceiling panel. This has now been done. One fully fiberglass replica has been made as well as patching of the existing zinc panel. For the existing panel the corroded areas were cut out and replica fiberglass sections spliced in. The result is very good.

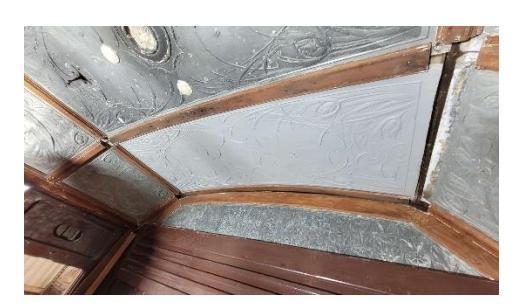
Fibreglass panel trial fitted to D36

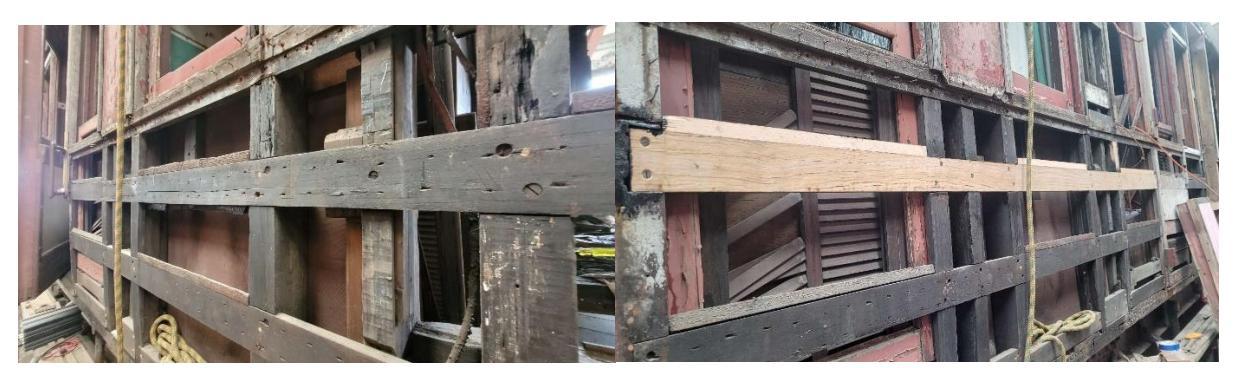
Before and after, replacement of rotted and split frame member.

- Removed windows and shutters from east side D36 compartment exposing frame fully. Cleaned frame, tightened all screws. Sections of rot cut out and new timbers spliced in. A new horizontal frame member from compartments D36 to C36 was cut and fitted as original was rotted and split.

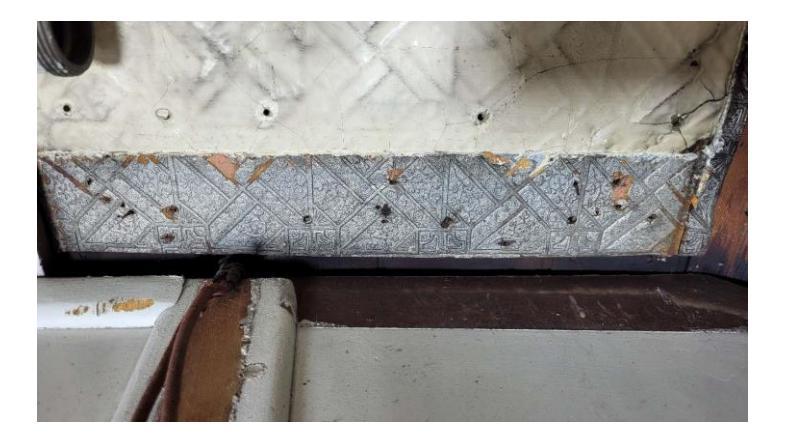
Lincrusta panelling in D36 lavatory ceiling revealed after removing ceiling trim to allow access to cabling

- Replaced rotted horizontal member below dog box door northwest corner.
- Continued priming and sanding outer fitted matchboards.
- Removed timber trims in D36 lavatory to help in chasing and replacing decrepit wiring loom. Discovered Lincrusta panelling remains behind trim. Speaking to Evan Rees of THNSW this maybe the only known existence of this panelling in early cars. Have decided to leave it as is at the moment as it is only thin and removing for duplication may destroy it.

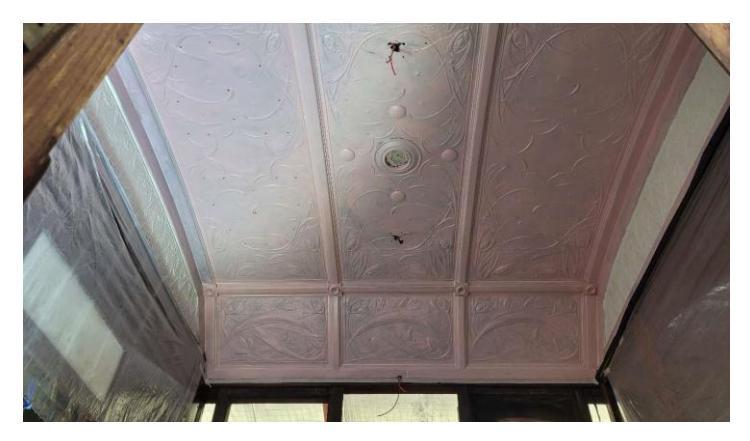
D36 compartment ceiling in undercoat

D36 compartment ceiling in ceiling white

- Undercoats applied to eastern guard wall matchboard, sanding between coats.
- Refitted D36 ceiling trimmings and applied undercoat and applied three coats of correct ceiling white paint applied to D36 compartment.

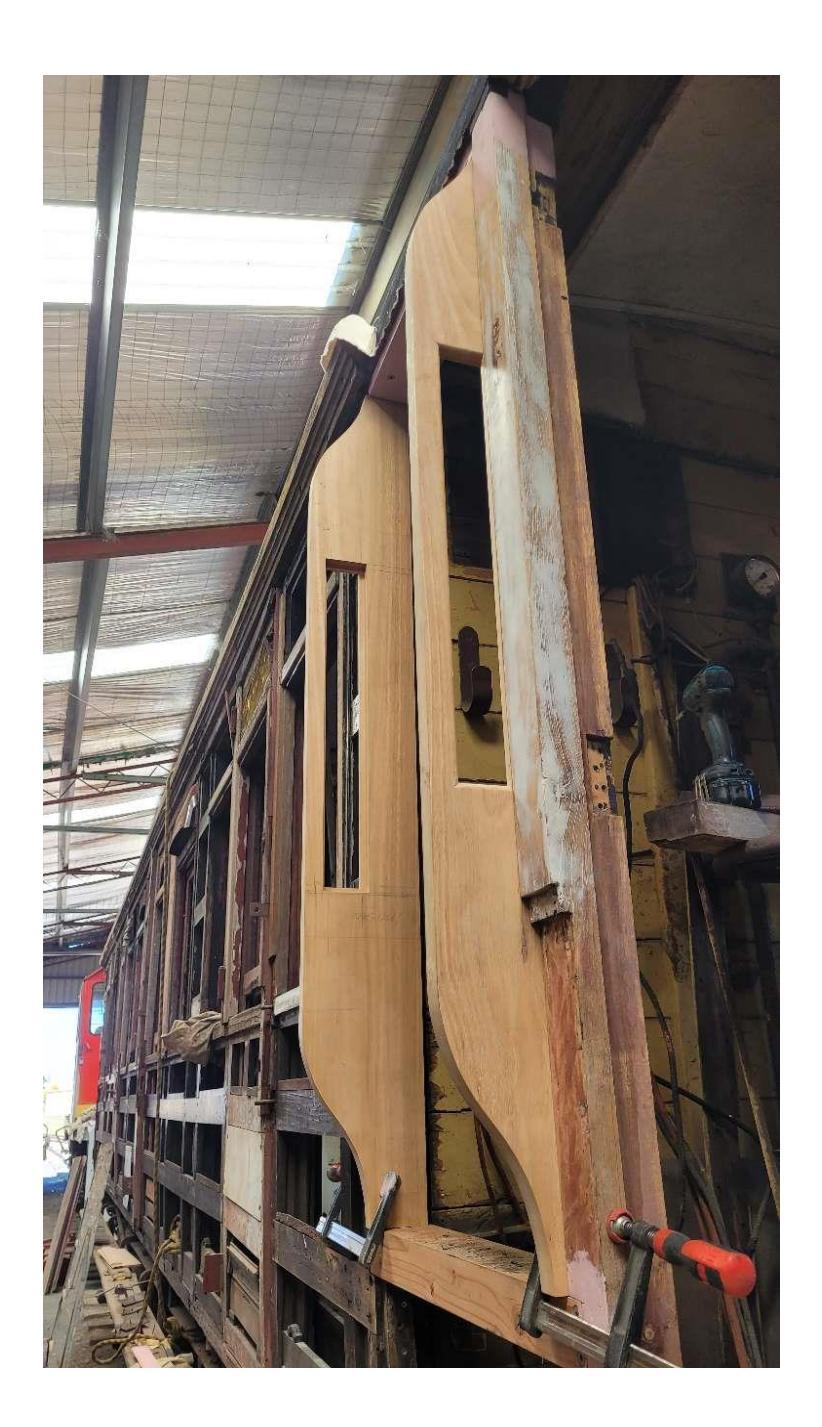
New east side ducket walls milled

New east side ducket walls temporarily placed

- Duplicated missing lower guard door spring loaded bolt.
- Removed N/E ducket. Ducket outer timbers are split and rotted and will require replacement. One of the ducket glass windows is broken. Horizontal noggin that supports the ducket was totally split and wasted. A new noggin made and fitted. Created templates of ducket walls to enable their replacement. Milled up new east and west ducket walls (four in total). Cut rebates for glass windows. Ordered and took delivery of glass for duckets. Fitted glass with linseed putty and timber quad as required.

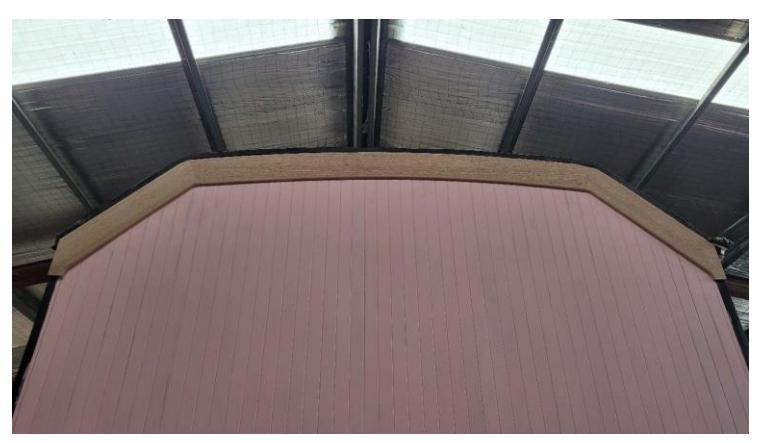
Guard wall under gutter top trim milled. Temporary fit up

- Created curved templates for north end guard wall under gutter trims using old rotted and buckled trims as a guide. Cut new trims using the templates.

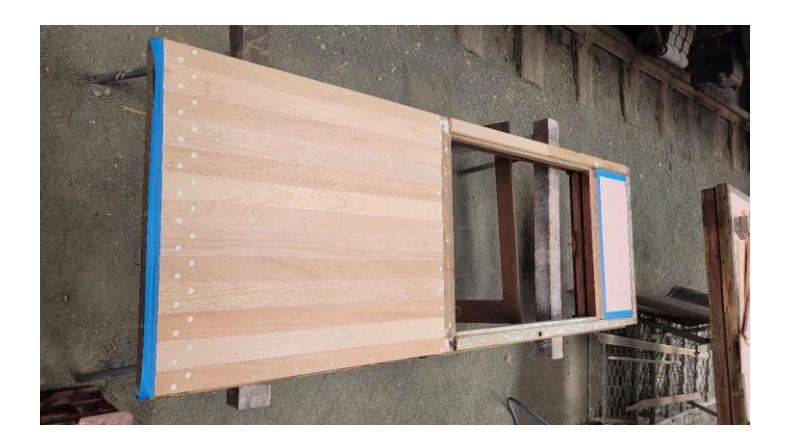
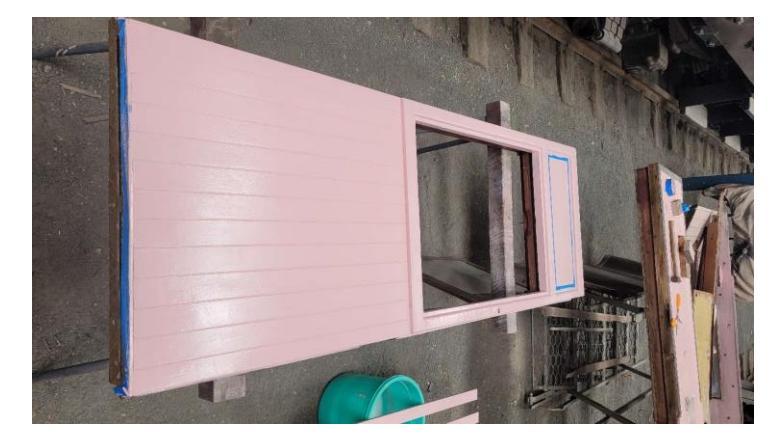
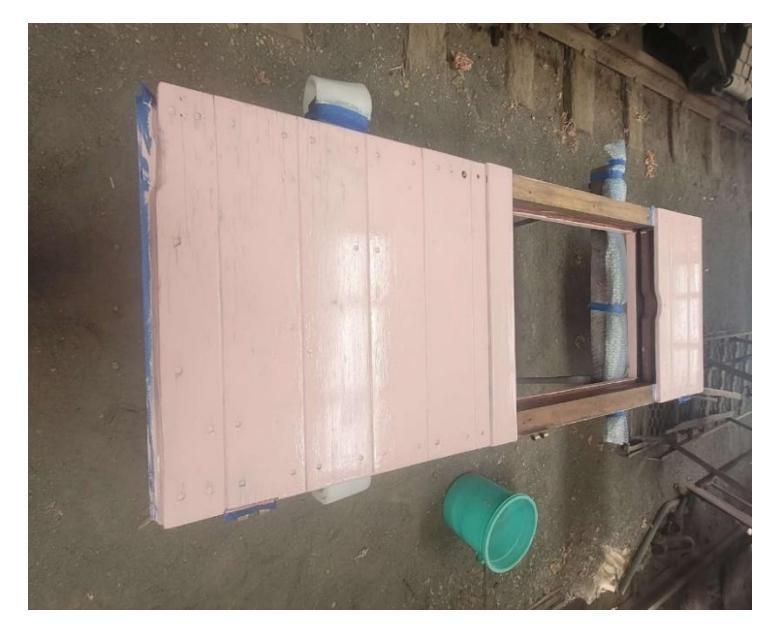
East side main guard door with new matchboard and name board

East side main guard door in primer

East side main guard door. Inside primed.

- Cut, primed and fitted matchboard to main east side guard door. Applied lower outer horizontal trim/kick board to guard door.
- Lightly sanded inner guard door for primer separation coat. Applied primer.

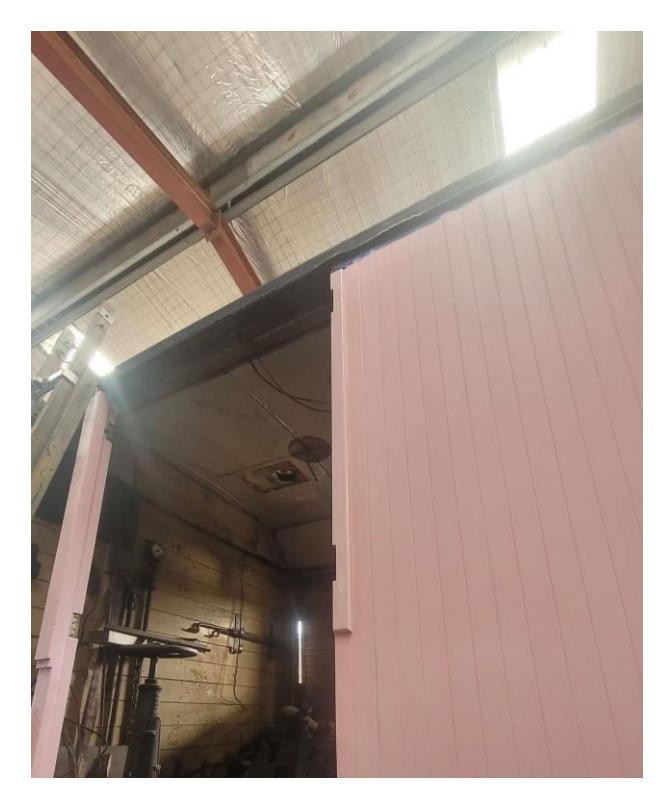
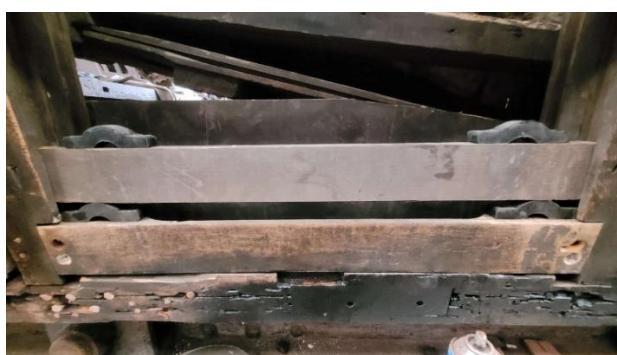
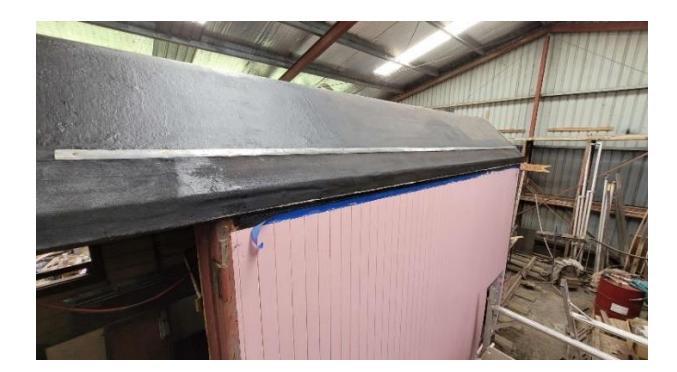
New window rubber bumpers

New guard door adjacent trims fitted

New window rubber bumpers fitted to D36 compartment northeast void

Aluminium strip over gutter canvas fitted

- Cleaned and lubricated all guard door hinges.
- Worked on D36 north east window void. Replaced all hardened rubber window bumpers with new. Tightened all timbers, cleaned all window drop light tracks. This section now ready for matchboard application (i.e. first section of Masonite replacement).

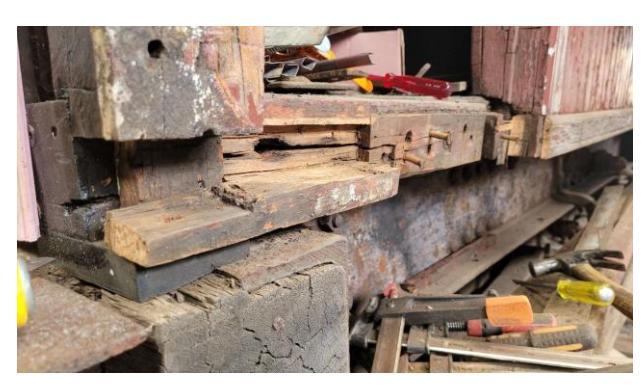
North west carriage corner under dogbox repairs. Rot cut out ready for new timber splicing

- Repaired northwest vertical timber corner, cutting out rotted sections and splicing in new timbers. Drilled and dowelled all old screw holes. There had been at least two repairs on this corner previously.

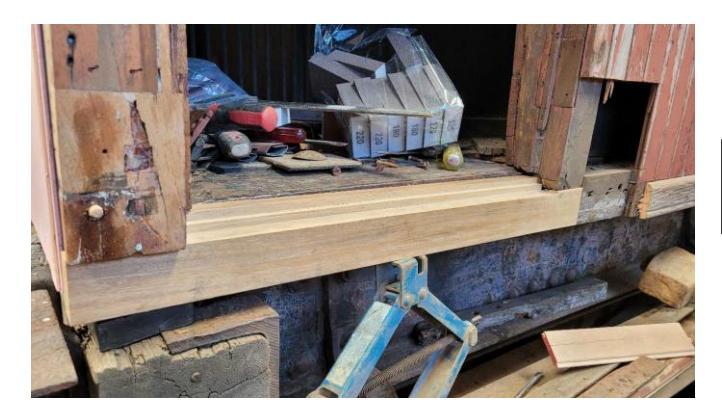
North west carriage corner under dogbox repairs. New timber spliced in

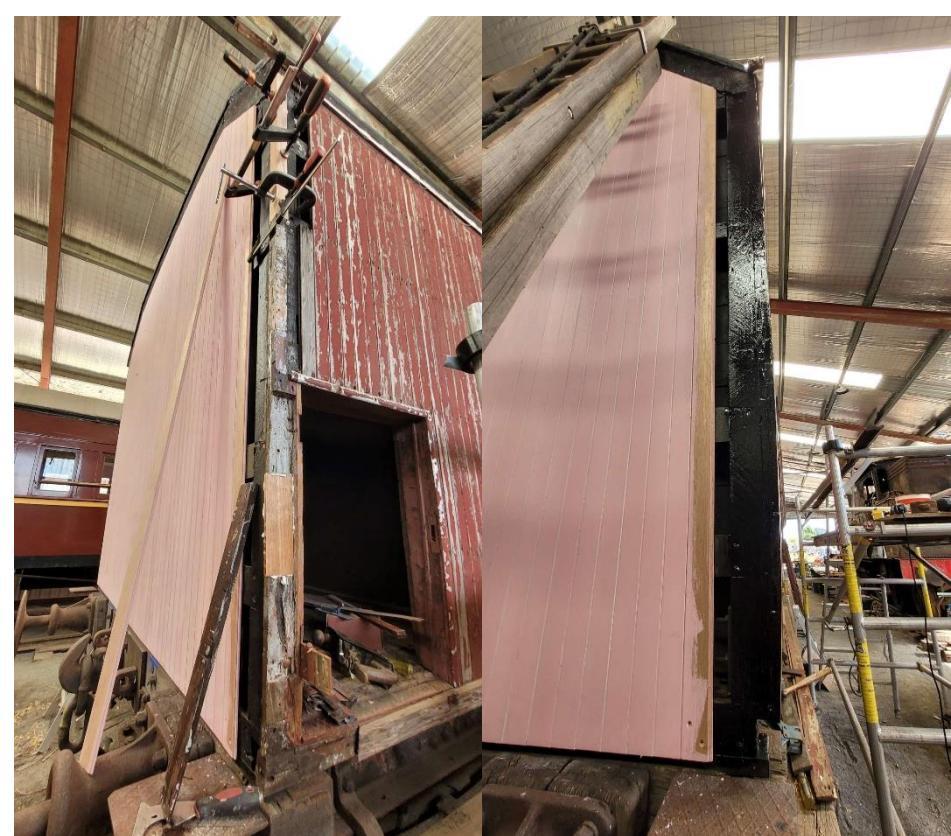
North west carriage corner repairs. Rot cut out, new timber spliced in

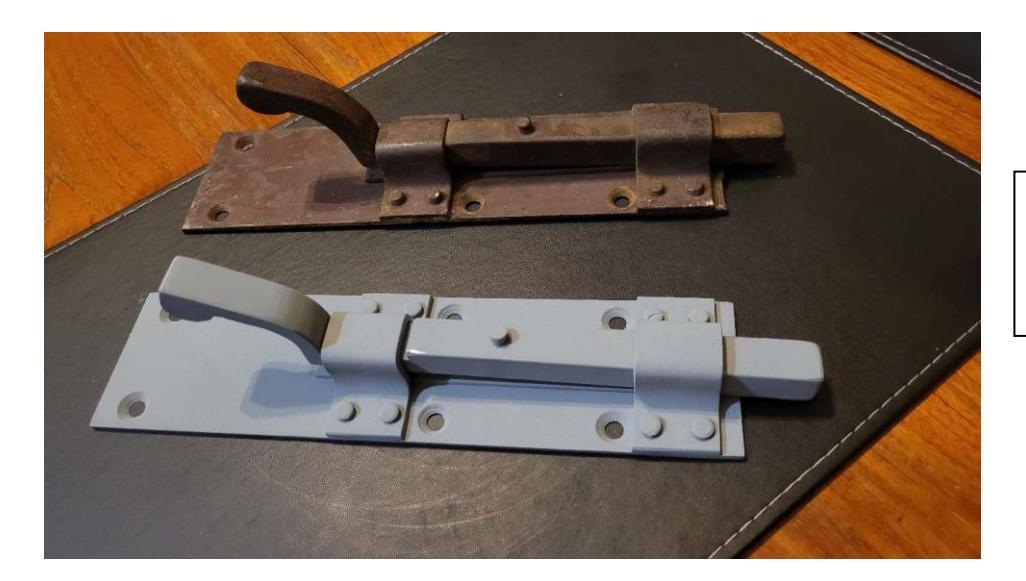
New spring loaded guard door bolt manufactured to replace missing bolt. Original shown on top. Kilometrage and Half Kilometrage Posts have to be put along side the line as we move forward to accreditation as a rail transport operator from Albion Street Oberon to Hazelgrove

- Applied gutter section canvas to roof above east side guard door.
- Cleaned and straightened removed aluminium gutter strip and refixed to roof.
- Assembled new guard door bolt from manufactured components.

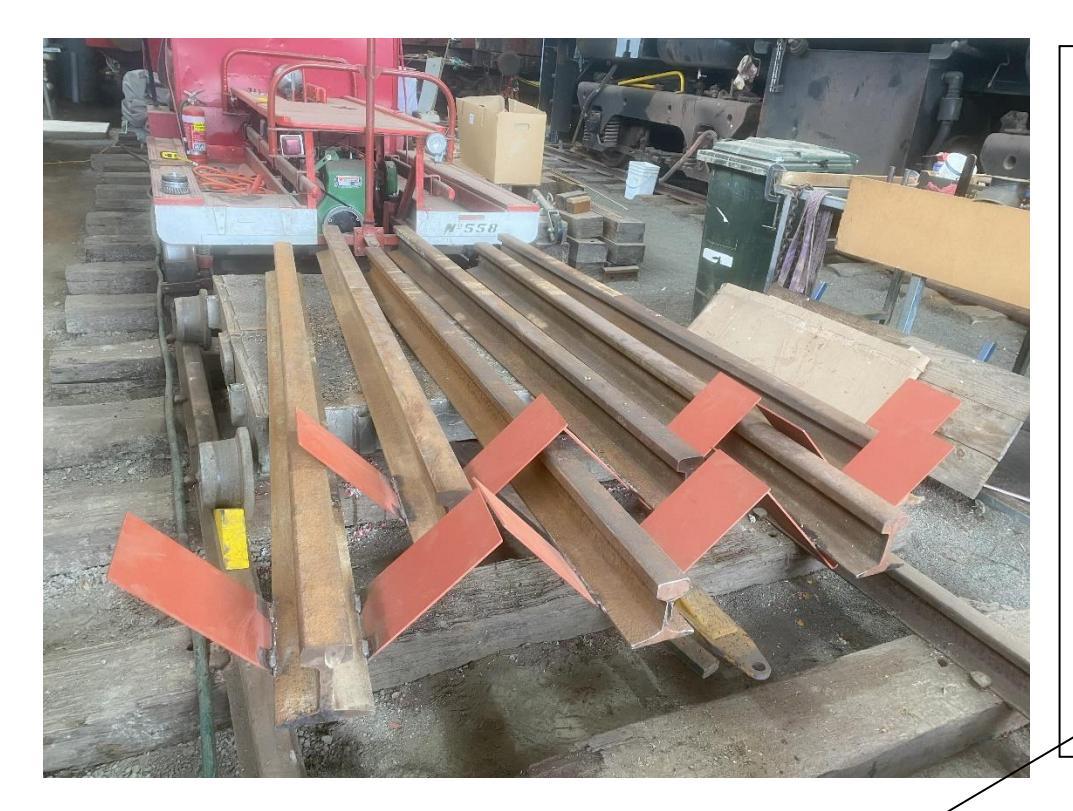
These posts have been made in the rolling stock shed from condemned rail and special laser cut plates.

They will treated with a rust resistant paint and then a top coat. The actual kilometre distance numbers will be fixed to the plates after painting.

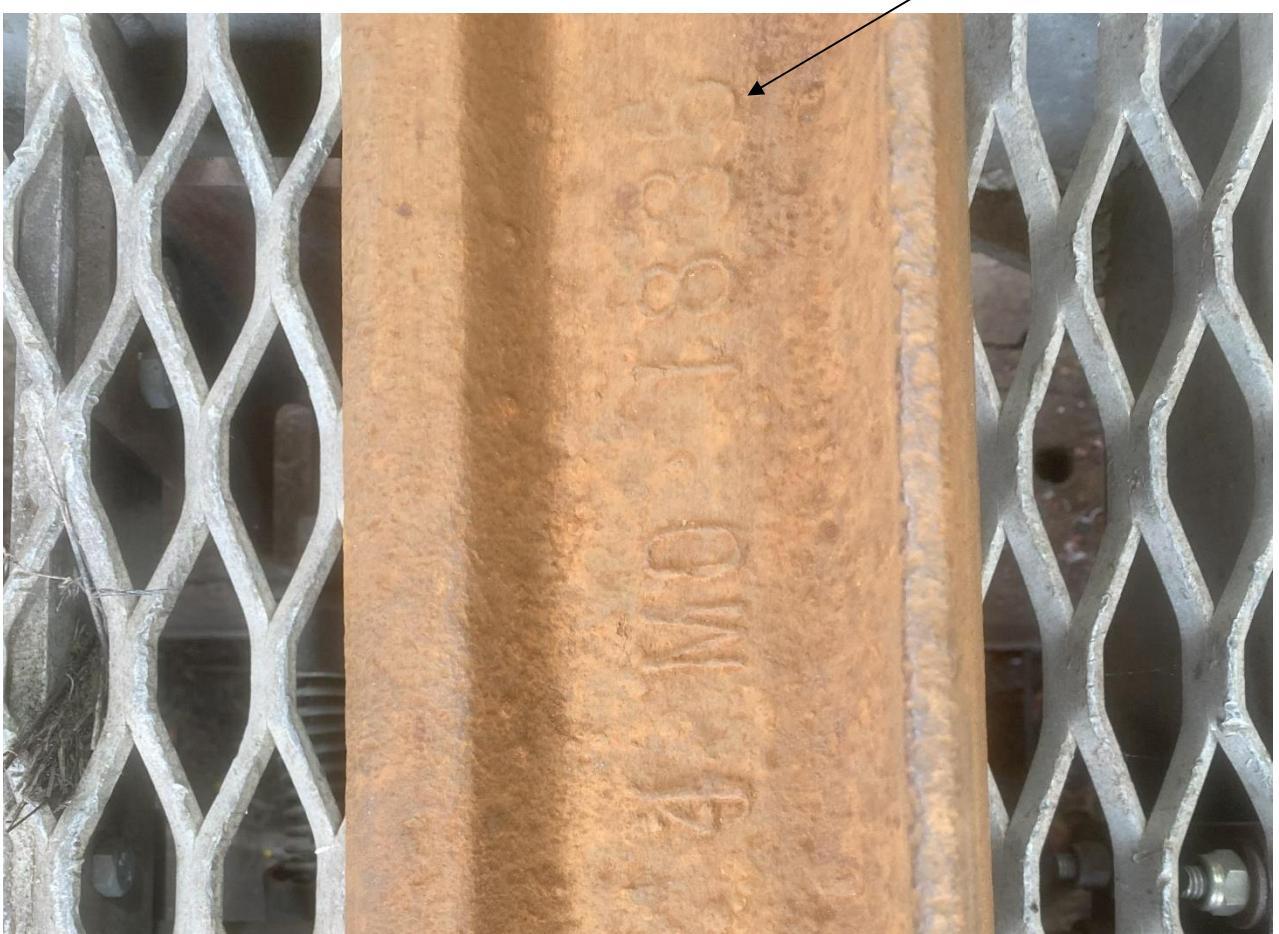
The photo below shows tha the section of rail used for one of them was manufactured in 4th month of 1885 and was taken from the line during repairs.

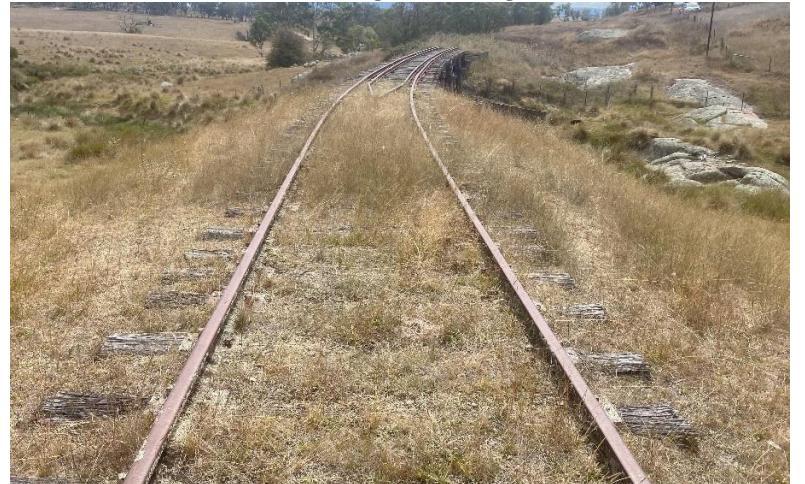
On the top side the rail looks to be in gauge but the sleepers are poor. In other places track is completely covered.

One of his roles is to find real time projects for second year students. They work in small groups (3 or 4) They have been given the task of looking at the Snakes Gully Bridge and finding a way to repair or restore it.
